Water for Mphero in Malawi

Vapor Intrusion Mitigation During Building Rehab

**ENVIRONMENTAL BULLETIN
CA RICH CONSULTANTS, INC.**

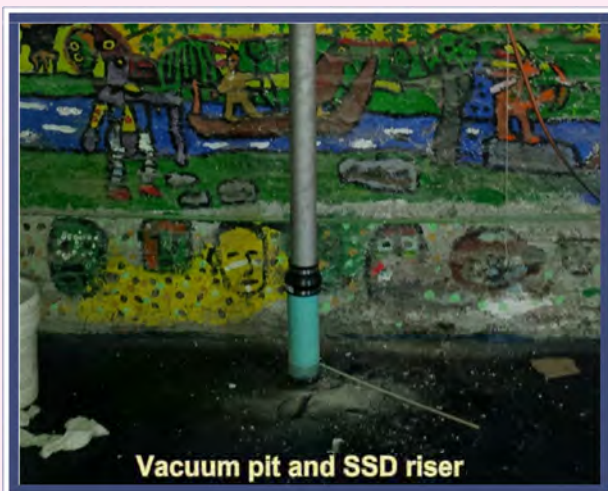
Vacuum pit and SSD riser

Measuring vacuum control across the building's sub-surface was achieved during the pilot test via coring through the basement slab at five locations and excavating vacuum pits. Four-inch diameter perforated PVC piping was then installed at each location and sealed to the slab. A FanTech fan was used to apply vacuum to the pits and multiple vacuum readings were then taken at several locations to measure the influence of the fan-induced vacuum beneath the building slab.

Installation of an additional vacuum pit was completed to extend vacuum beneath the entire building footprint and then the SSD system piping was installed. Because the building is six-stories in height, ladders could not be used to install the piping. In addition, due to logistical Property constraints, erecting scaffolding was estimated to take two to three weeks and was deemed impractical.

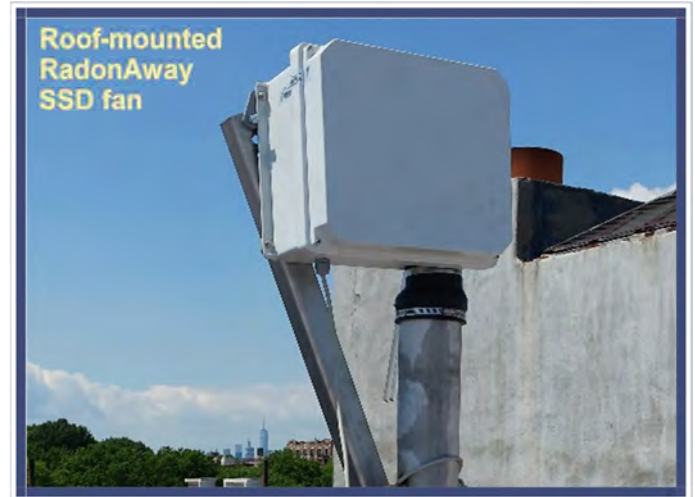
Roof-mounted RadonAway SSD fan

dition resulted in a necessary modification in system design to substitute a RadonAway fan in place of the originally-specified FanTech fan. The RadonAway Fan was preferred as it will induce greater air flow to the vacuum pits with little increase in vacuum.

The SSD system is now in the final stages of completion pending installation of an electrical connection to power the two rooftop RadonAway fans. Once the fans are powered, a system startup test will be conducted to confirm site-wide vacuum and proper operation. During the test, any issues related to system operations shall be addressed. To confirm the continued effectiveness of this vapor mitigation strategy at the Property, indoor air quality samples will be collected from the basement during the heating season, as per NYSDOH requirements.

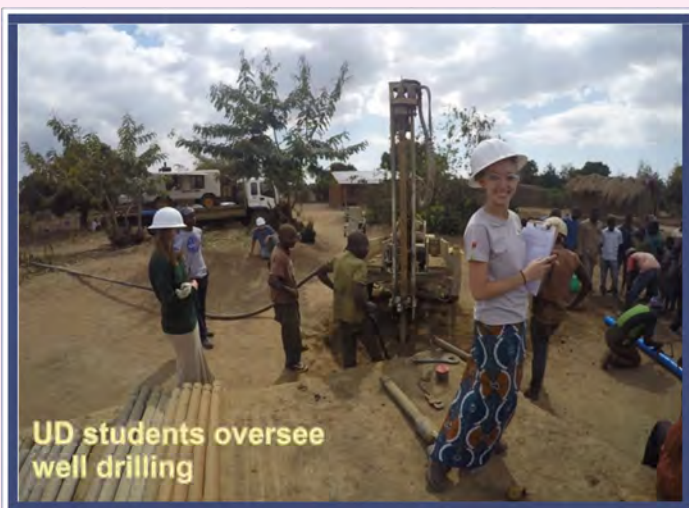
UD students oversee well drilling

To determine the ideal locations for prospective well sites, two test boreholes approximately 500m apart, were located by geophysical resistivity profiling, then drilled using the air rotary drilling method down into the top of what can be described geologically as a buried, syenitic granite

These boreholes were then screened & cased, developed, and pump-tested using a locally-hired driller overseen by the EWB-UD Team. Hydrogeologic conditions encountered between the two boreholes varied considerably. Total borehole depths, based upon local lithology (drill samples), were 37.1m & 40.5m. Both test sites were then field-located (surveyed) by handheld GPS. The first borehole exhibited the most promising pump test results. It was completed with a sanitary cement grout seal, a concrete well pad (requiring a minimum 72 hrs. for cement to cure), and installation of an 'Afridev' hand pump. The Afridev hand pump, approved by the Malawi government, is a robust, simple design, manual water pump that is relatively easy to repair. Finally, fresh formation groundwater samples were tested for potability using field sampling kits (bacteria, pH, TDS, chloride, nitrates, metals, etc.) to ensure the well water was safe for consumption. After subsequent sanitizing, the first finished well located in the heart of the village immediately became subject to an almost continuous daytime pumpage by appreciative Villagers.
