PFAS in Ground Water - What Is It? How Bad Is It?

Remedial Action for a Real Estate Transaction

ENVIRONMENTAL BULLETIN
CA RICH CONSULTANTS, INC.

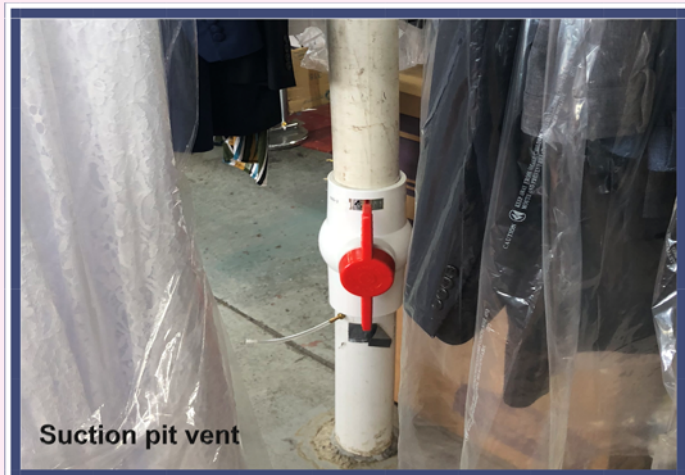
Suction pit vent

CA RICH performed a pilot test including the installation of three suction-pit-type vents through the floor slab within the dry cleaner along with six temporary vacuum monitoring points. The vents were then individually and collectively activated using a Fantech “radon” fan and also a 2.5 hp regenerative blower to determine the amount of vacuum necessary to achieve the minimum vacuum required by the County at each monitoring point. The system was then designed using the data from the pilot test and a work plan was submitted to the County for review and approval.

Following receipt of approval from the County, the three SSD vents were manifolded together and piped to a 2.5 hp blower located in a small shed behind the dry cleaner. Exhaust from the blower was conveyed to a stack extending several feet above the roof of the building.

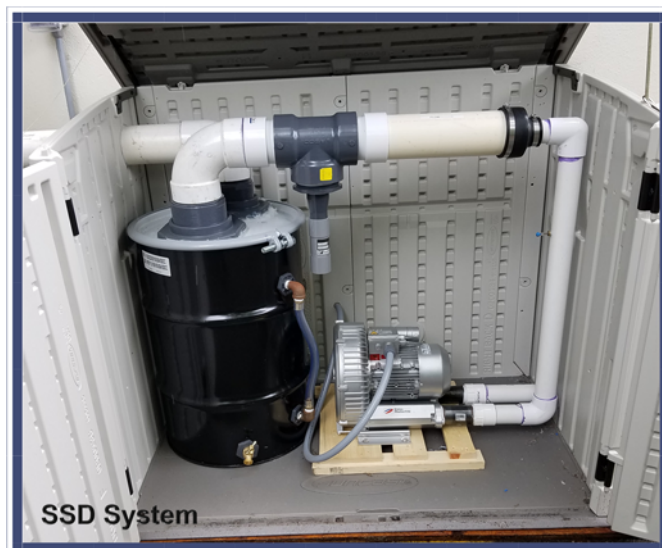
SSD System

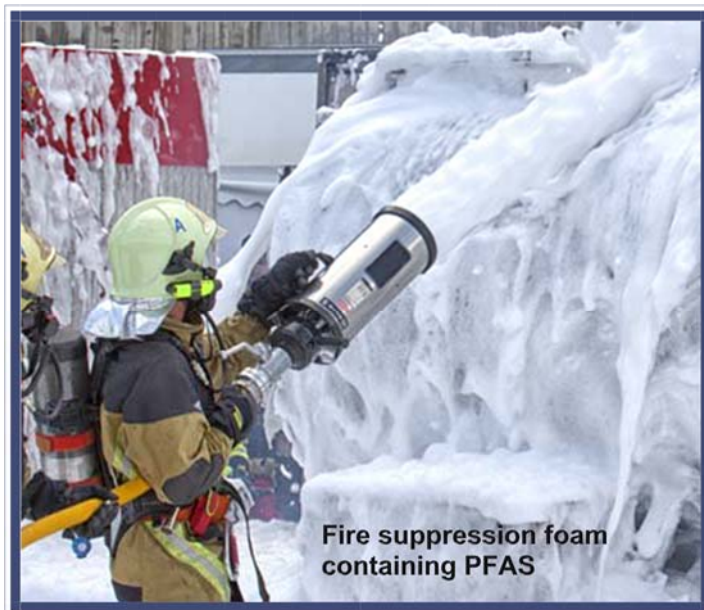
Fire suppression foam containing PFAS

PFAS groundwater and soil contamination occurs through the utilization of aqueous film forming foams such as fire-fighting (to suppress gasoline fires) and/or at fire-training facilities; at airports and petroleum storage terminals; from metal plating & finishing process-
